# Climate Risk Assessment at the Asset Level

## The Wall, Utrecht

This case study — The Wall, a shopping centre in Utrecht, the Netherlands — demonstrates a high-level physical climate risk screening and considerations that should be taken into account for a real estate asset. We assess The Wall's exposure and vulnerability to four climate hazards to demonstrate what data is available and what is not for these type of assets. This will allow to start a discussion with asset managers and owners about what science can and cannot do within the realm of climate change adaptation.

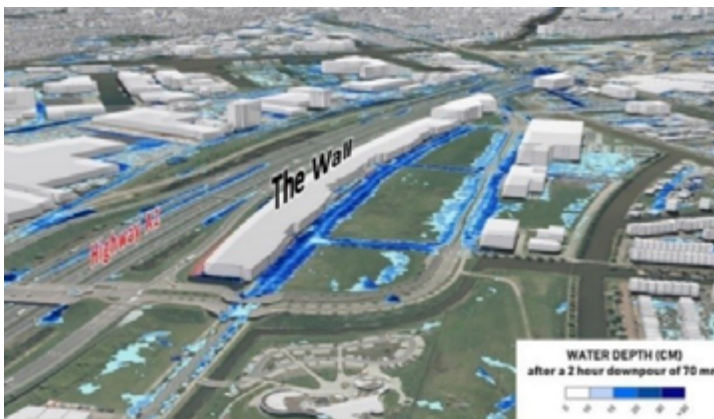
Figure 3. A simulation of the potential flooding following a 2 hour downpour of 70 mm per hour shows that the main access roads to The Wall and part of the A2 highway can be flooded and be inaccessible. Inundation depth is estimated between 20 - 30 cm, potentially damaging the buildings foundation, grid infrastructure or sewer systems, depending on threshold heights of the construction. Source: ClimINVEST, 2019; KNMI, 2014.

Although it has not yet been severely impacted by pluvial flooding, The Wall is located in a flood zone on highway A2 and surrounding infrastructure has not been sufficiently reinforced with pluvial flood management systems. The highway is part of a road system that has demonstrable difficulty draining during periods of intense rainfall ([Bles, et.al., 2012](#)). This can disrupt consumer and supplier access to the shopping centre, as well as cause physical damage to the building and merchandise.

In the case of pluvial flood risk, an extreme rainfall event of 70mm in 2 hours has a probability of occurrence of around once every 100 years. Climate change is likely to double this risk to once every 50 years by the end of the century. Less severe rainfall events will occur more frequently and temporarily disrupt the traffic flow on the A2 highway, thereby potentially affecting business at The Wall. Road network and sustainable urban drainage systems should be well maintained and where possible upgraded, e.g. installation of local bioswales for stormwater drainage to manage vulnerability. The Wall is highly exposed to pluvial flooding. It's vulnerability is partially mitigated by policies that provide affected assets with protection, as well as urban drainage systems.

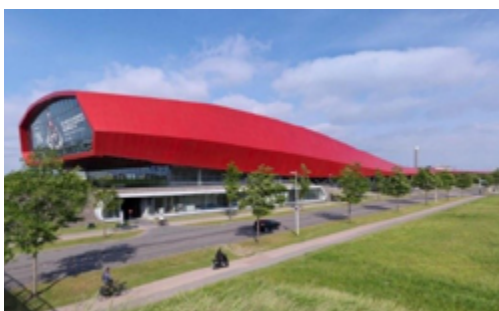
Figure 1. The Wall shopping centre in Utrecht, the Netherlands. Source: ClimINVEST, 2019

The Wall is a 65 000m<sup>2</sup> shopping centre in Utrecht, the Netherlands. The shopping centre sits by the A2 highway, the most important north-south connection in the Netherlands, vital for connecting the Amsterdam metropole to other European markets.

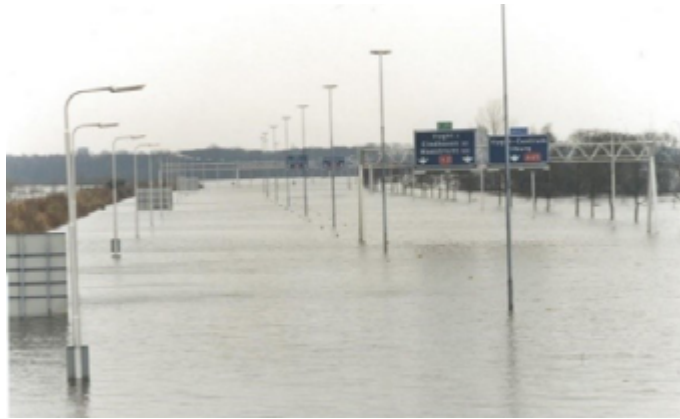
Figure 2. Example of fluvial flooding risks: High water events in 1995 and in 2005 caused a major dike burst near the city of Den Bosch (30 km south of Utrecht), causing the highway A2 to be flooded for multiple weeks. Source: Dutch Ministry of Infrastructure and Water Management, 2005.

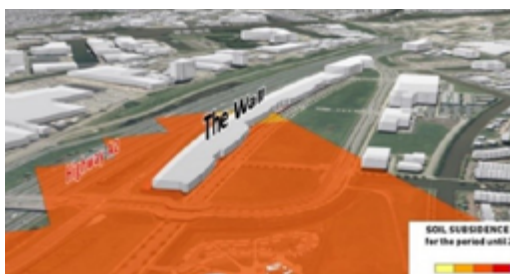
Figure 4. The expected total soil subsidence (in cm) when no adaptation measures are being taken for the period until 2050. For the area around The Wall, an additional 25% of the subsidence (5-10 cm) subsidence may occur as a result of climate change under all KNMI14 climate change scenario's. Source: ClimINVEST 2019; KNMI, 2014.

Although the foundation of The Wall itself is firmly anchored on concrete piles 30 meters deep, the surrounding infrastructure may subside, which means increased maintenance costs and a risk of deterioration of the rainwater drainage system. The northern part of the study area may be affected by moderate rates of soil subsidence. However, the asset itself is firmly founded on piles, hence this risk is deemed low.

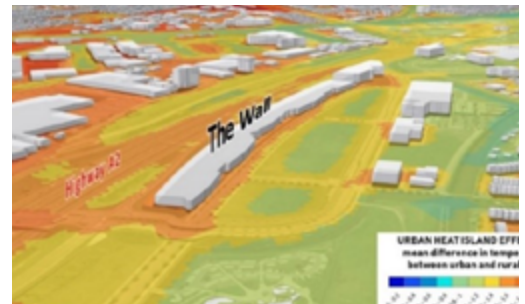
Figure 5. The local urban heat island effect in °C around the area of The Wall with the shopping centre is clearly visible (Klimaat-effectatlas, 2019 and KNMI 2014). With its concrete roof top and 14000 parking spots, The Wall is clearly not able to absorb the radiation, creating a local island of heat to the city-level heat island effect of around 1.5 degrees Celsius.  
Source: ClimINVEST, 2019; KNMI, 2014.
